Sayı
Our Reference: 3215Konu
Subject : **MAIB Güvenlik Bülteni – MV ZARGA Gemisinde Manevrada Meydana Gelen Ciddi Yaralanma Hk.**

GÜVENLİK BÜLTENİ

SB1/2015

**Mooring line failure resulting in serious injury to a
deck officer on board
Zarga
alongside South Hook LNG terminal,
Milford Haven
on 2 March 2015**

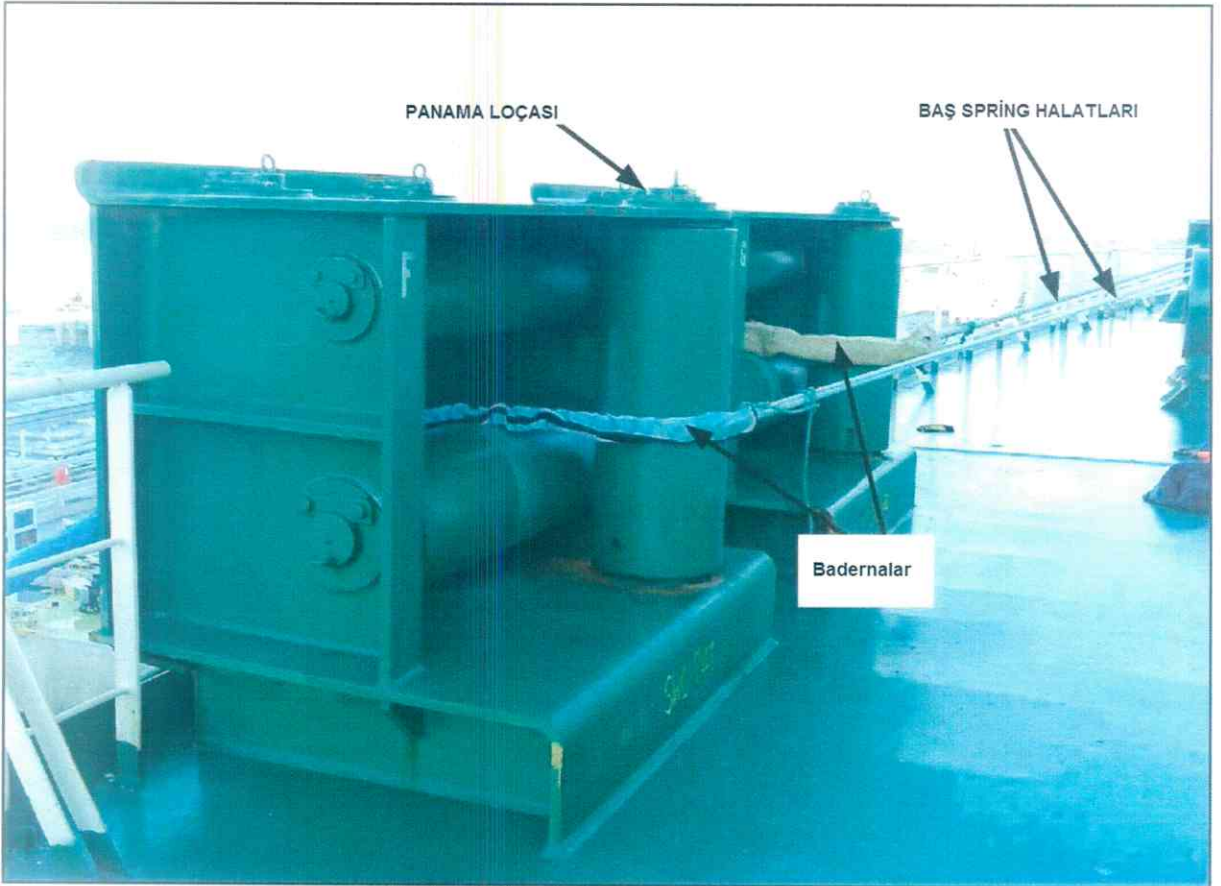
Figüre 2: İskele baş omuzluk kurtağzı

Zarga gemisi kazanın meydana gelmesinden 40 dakika önce, geminin tüm halatlarla rıhtıma bağlandığını rapor ederek bağlı römorkörü mola etmiştir. Sonrasında esen güçlü rüzgar neticesinde gemi rıhtımdan açmaya başlamıştır. Mürettebat bu esnada halatlara ¹badernaları yerleştirmektedir (Figür 2). Römorkörler halihazırda mola edilmişken (hemen geri çağırılması gerekirken), rıhtımdan açan Zarga gemisini tekrar yanaştırmak için gemi kaptanı, baş taraf manevrasından sorumlu güverte zabıtine baş spring halatını vira etmesi direktifini vermiştir.

Sorumlu Vardiya Zabiti, iskele baş omuzluktaki (panama halat loçası) kurtağzındaki baş spring halatının arkasına geçmiş,(Figür 2 ve 3) diğer mürettebat ise sorumlu güverte zabitinden aldığı komutları halat vinçi operatörüne iletmek için onun ilerisinde pozisyon almıştır. Vinç operatörü baş spring halatını vira etmek için teşebbüste bulunduğu anda aşırı yükten dolayı defalarca halat kaçırmış ve durmuştur. Yaklaşık olarak 10 dakika kadar sonra halatın çatırdamaya başladığı duyulmuş ve akabinde halat aniden kopmuştur. Halatın kopmasıyla, baş omuzluktaki kurtağzından halatın kopan kısmına kadar olan tarafı kırbaç etkisi yaratarak Görevli Güverte Zabiti'nin başına çarpmış ve kurtağzından geri denize düşmüştür.

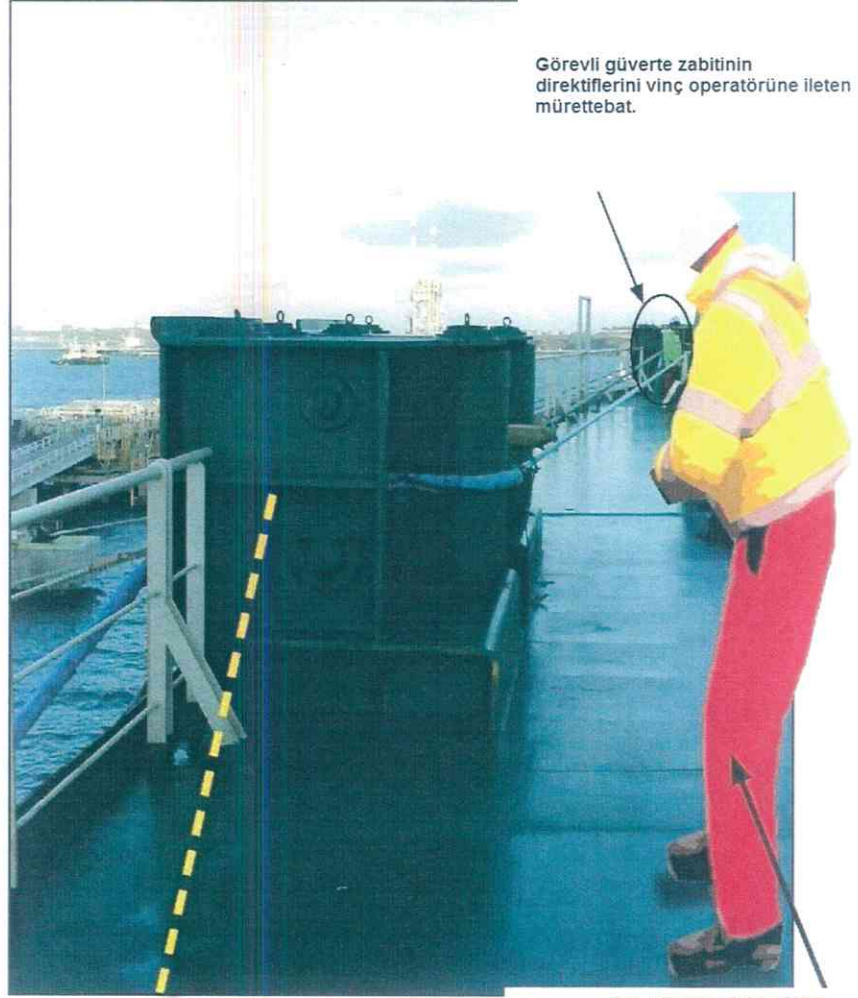
Figür 3: Baş taraf manevra ekibi Sorumlu Güverte Zabiti, iskele baş omuzluk panama loçası yakınında resimdeki gibi pozisyon almıştır.

Görevli güverte zabitinin direktiflerini vinç operatörüne ileten mürettebat.

Baş tarafta manevradan sorumlu görevli güverte zabiti

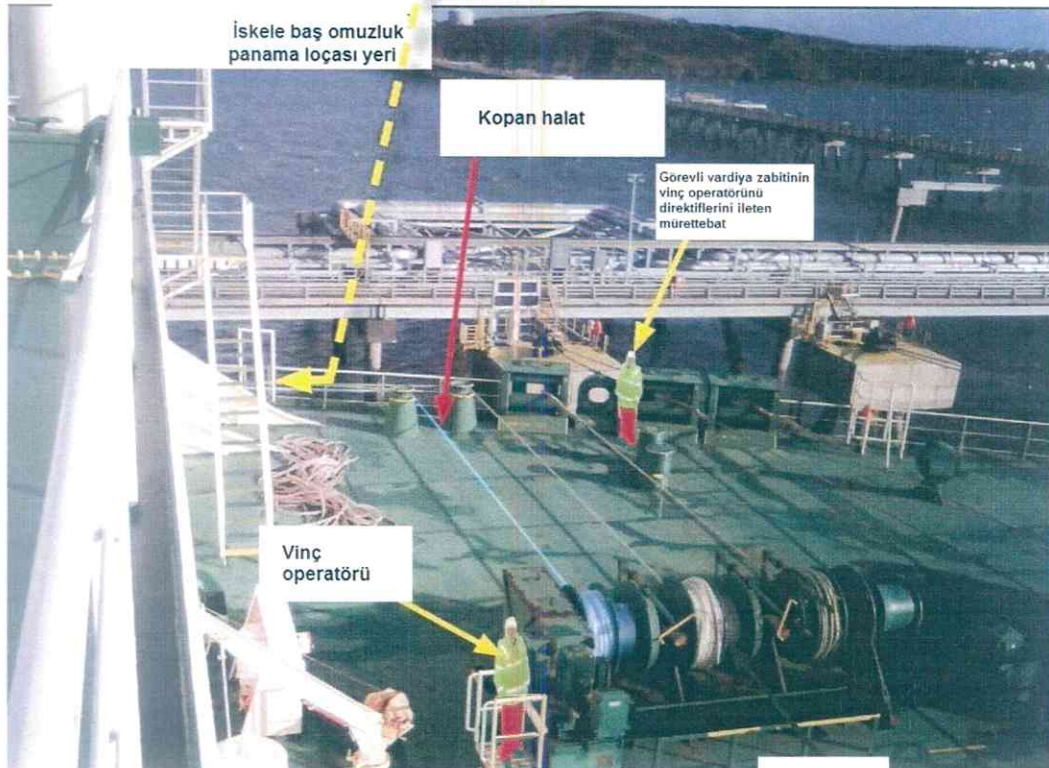
İskele baş omuzluk panama loçası yeri

Kopan halat

Görevli vardiye zabitinin vinç operatörünü direktiflerini ileten mürettebat

Vinç operatörü

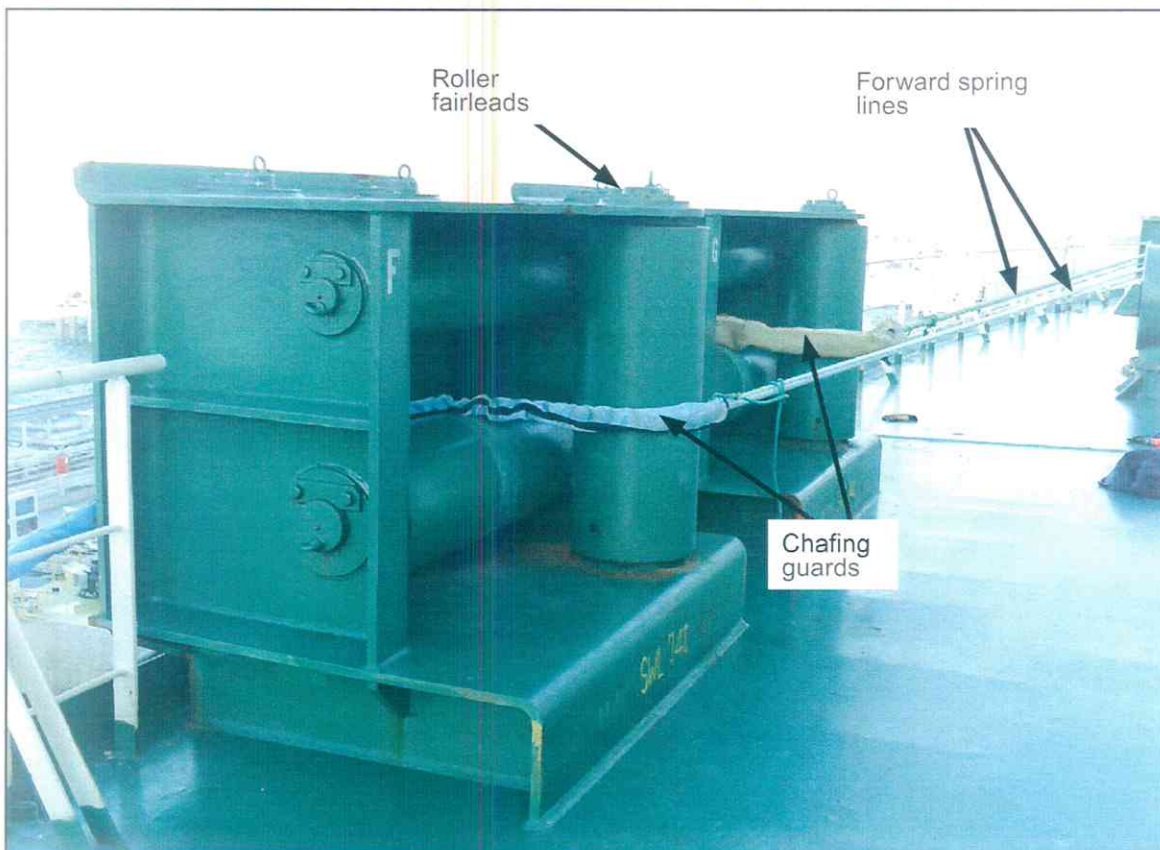
Figure 2: Port-shoulder roller fairlead

Zarga was declared *all fast* alongside about 40 minutes prior to the accident and the attending tugs were let go. The vessel subsequently moved out of position in the gusty wind conditions during which time the mooring teams were fitting chafing guards to the lines (**Figure 2**). As the tugs had already been released, the master instructed the officer in charge (OIC) of the forward mooring party to tension the forward spring lines to warp *Zarga* back into the correct position.

The OIC positioned himself aft of the forward springs' port-shoulder roller fairlead (**Figures 2 and 3**), and positioned a second crewman forward of him in order to relay his orders to the winch operator. As the winch operator attempted to heave in on the springs, the winch repeatedly stalled and rendered¹. After about 10 minutes, one of the spring lines began to rattle and creak, and then suddenly parted (**Figure 4**). The section of the line between the break and the port-shoulder roller fairlead struck the OIC on his head as it whipped back before going overboard through the fairlead.

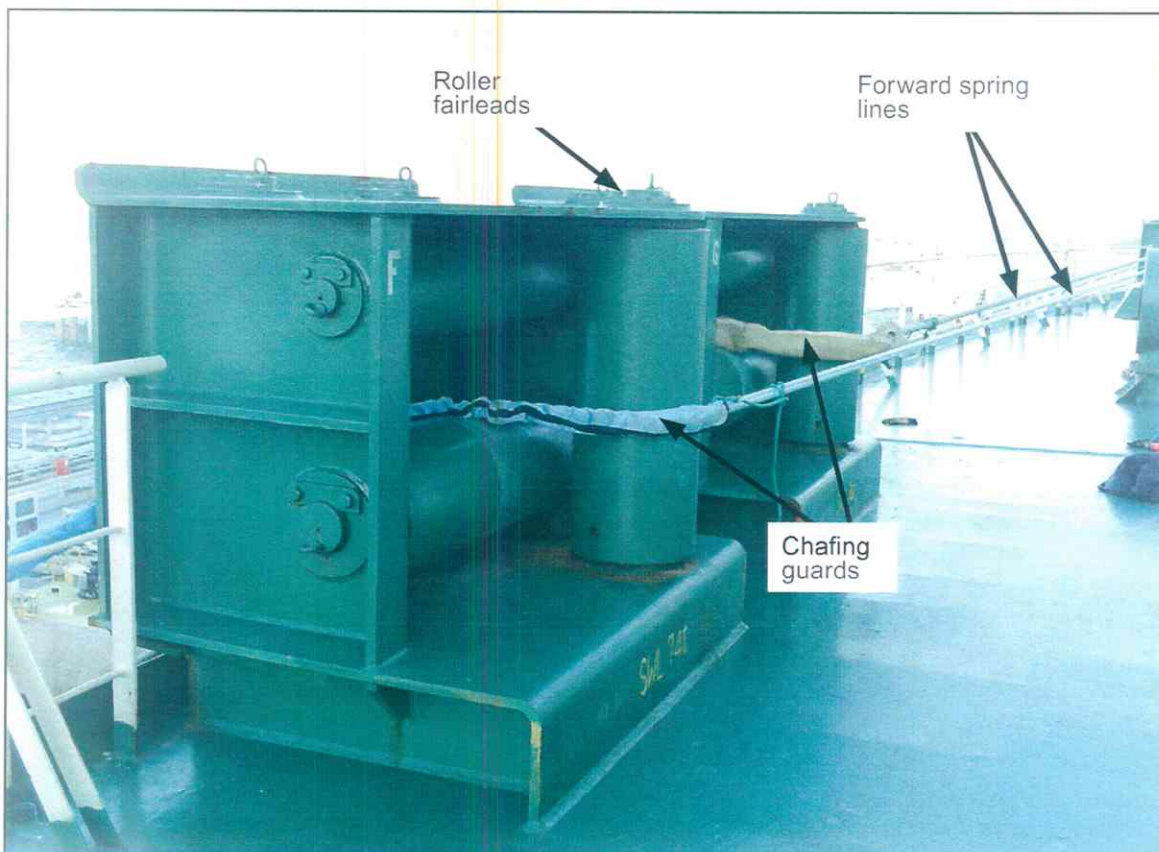
Figure 2: Port-shoulder roller fairlead

Zarga was declared *all fast* alongside about 40 minutes prior to the accident and the attending tugs were let go. The vessel subsequently moved out of position in the gusty wind conditions during which time the mooring teams were fitting chafing guards to the lines (**Figure 2**). As the tugs had already been released, the master instructed the officer in charge (OIC) of the forward mooring party to tension the forward spring lines to warp *Zarga* back into the correct position.

The OIC positioned himself aft of the forward springs' port-shoulder roller fairlead (**Figures 2 and 3**), and positioned a second crewman forward of him in order to relay his orders to the winch operator. As the winch operator attempted to heave in on the springs, the winch repeatedly stalled and rendered¹. After about 10 minutes, one of the spring lines began to rattle and creak, and then suddenly parted (**Figure 4**). The section of the line between the break and the port-shoulder roller fairlead struck the OIC on his head as it whipped back before going overboard through the fairlead.
