Sayı
Our Reference: 3215Konu
Subject : **MAIB Güvenlik Bülteni – MV ZARGA Gemisinde Manevrada Meydana Gelen Ciddi Yaralanma Hk.**

GÜVENLİK BÜLTENİ

SB1/2015

**Mooring line failure resulting in serious injury to a
deck officer on board
Zarga
alongside South Hook LNG terminal,
Milford Haven
on 2 March 2015**

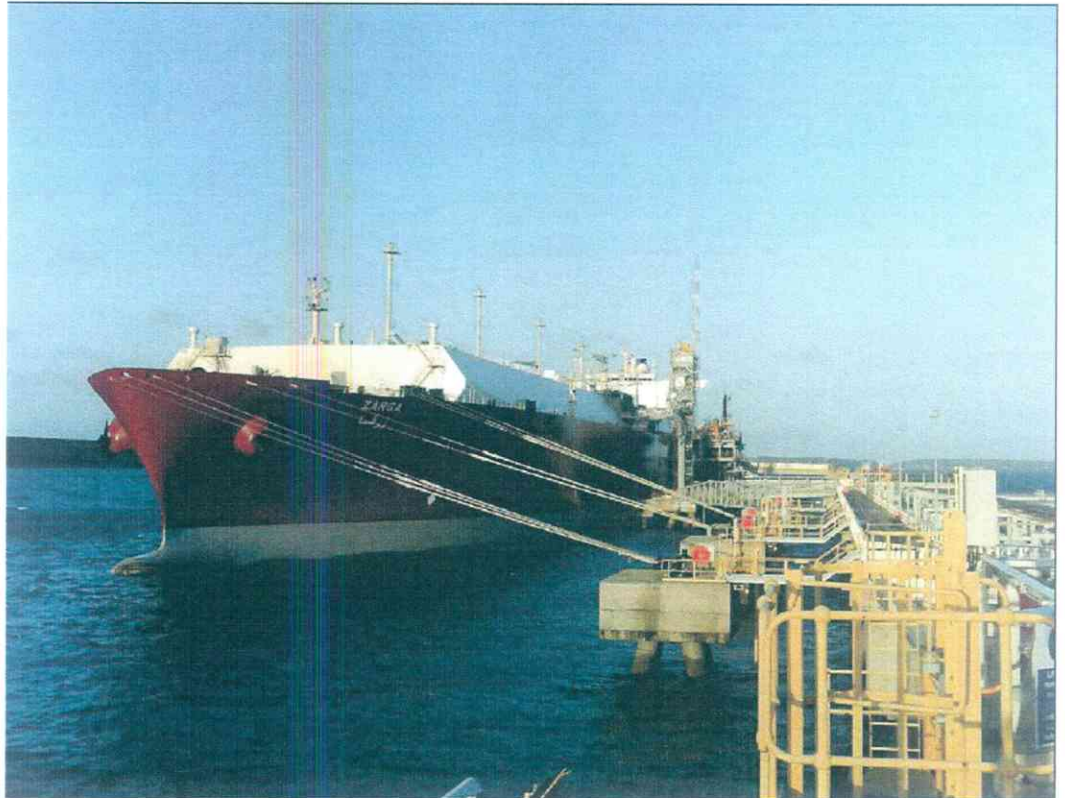
Zarga (Figür 1) isimli LNG Tankerinin güverte zabiti, Güney Hook LNG, Milford terminaline yanaşma esnasında, kopan bir halatın başına çarpması sonucu yaralanmıştır. Baş tarafta yanaşma manevrasından sorumlu olan zabıt, helikopterle gemiden alınarak acil ameliyat için sağlık kuruluşuna nakledilmiştir.

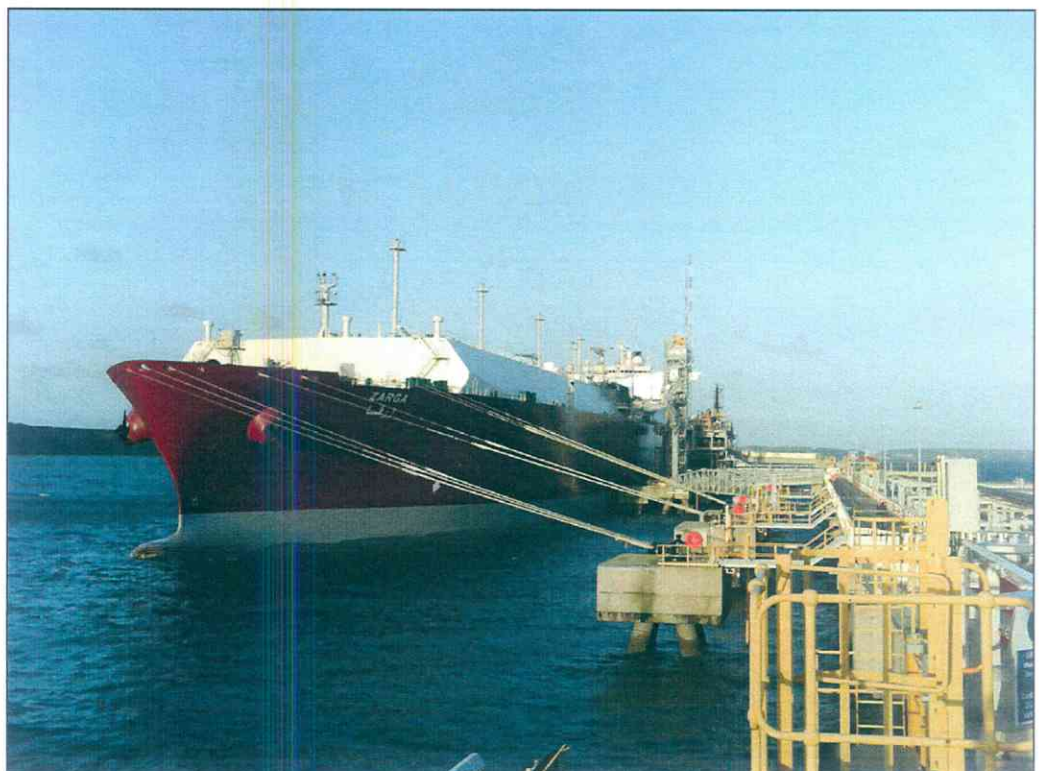
Figure 1: *Zarga* alongside South Hook LNG terminal

On 2 March 2015, a deck officer on board the LNG tanker, *Zarga* (**Figure 1**), suffered severe head injuries when he was struck by a mooring line that parted during a berthing operation at the South Hook LNG terminal, Milford Haven. The officer, who was in charge of the vessel's forward mooring party, was airlifted to a specialist head injuries trauma unit for emergency surgery.

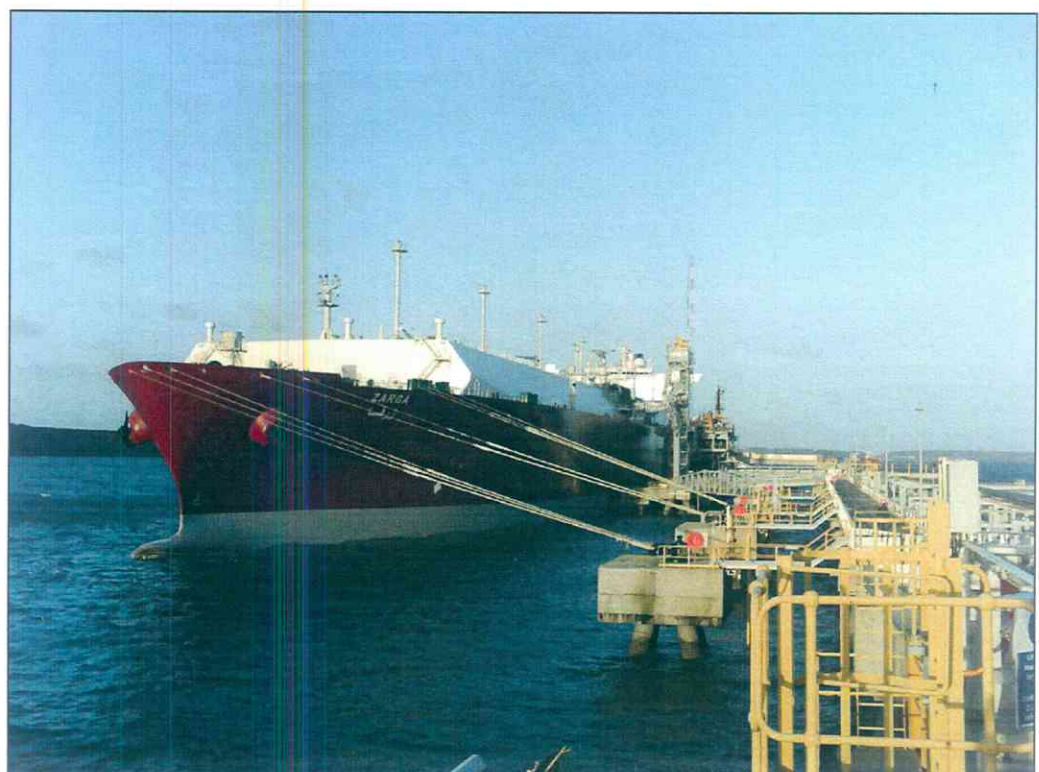
Figure 1: *Zarga* alongside South Hook LNG terminal

On 2 March 2015, a deck officer on board the LNG tanker, *Zarga* (**Figure 1**), suffered severe head injuries when he was struck by a mooring line that parted during a berthing operation at the South Hook LNG terminal, Milford Haven. The officer, who was in charge of the vessel's forward mooring party, was airlifted to a specialist head injuries trauma unit for emergency surgery.
